Docket No. 217 – Development and Management Plan Inspection

Northeast Utilities Service Company Certificate of Environmental Compatibility and Public Need for the construction of a 345-kV electric transmission line and reconstruction of an existing 115-kV electric transmission line between Connecticut Light and Power Company's Plumtree Substation in Bethel, through the towns of Redding, Weston, and Wilton, and to the Norwalk Substation in Norwalk, Connecticut.

Date: June 28-29, 2006

Location: Transition Stations: Hoyts Hill, Archers Lane, Norwalk Junction

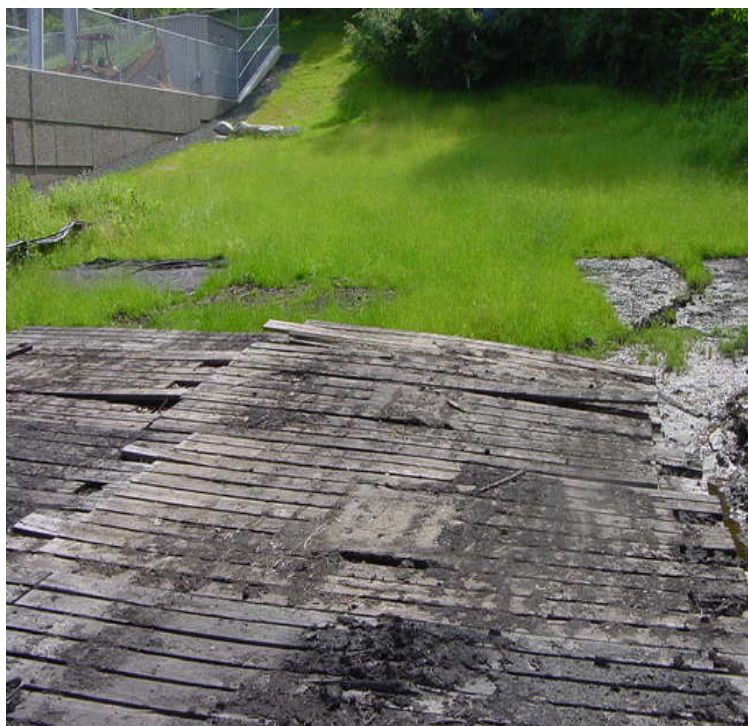
Hoyts Hill Transition Station: Photo on the left shows mats in place to access the site off Rt 58. Old filter bags will be removed during this access. Photo on the right shows a view of the station pad where wire work had occurred.

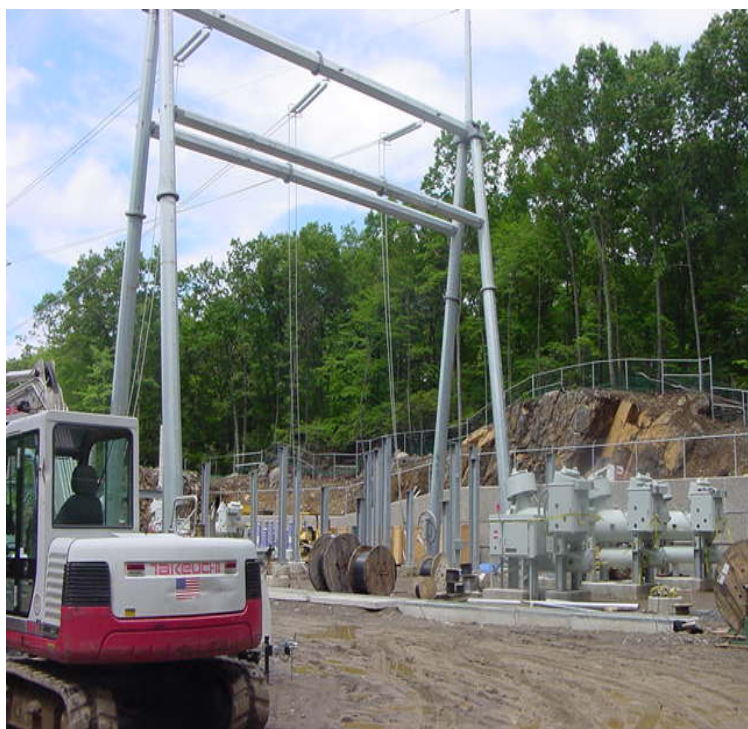
Archers Lane: Photo on the left shows the ongoing work in the station yard. Photo on the right shows where run-off from the ROW access road is almost overtopping the silt fence at the second wetland crossing, adjacent to the station. 6/29/06.

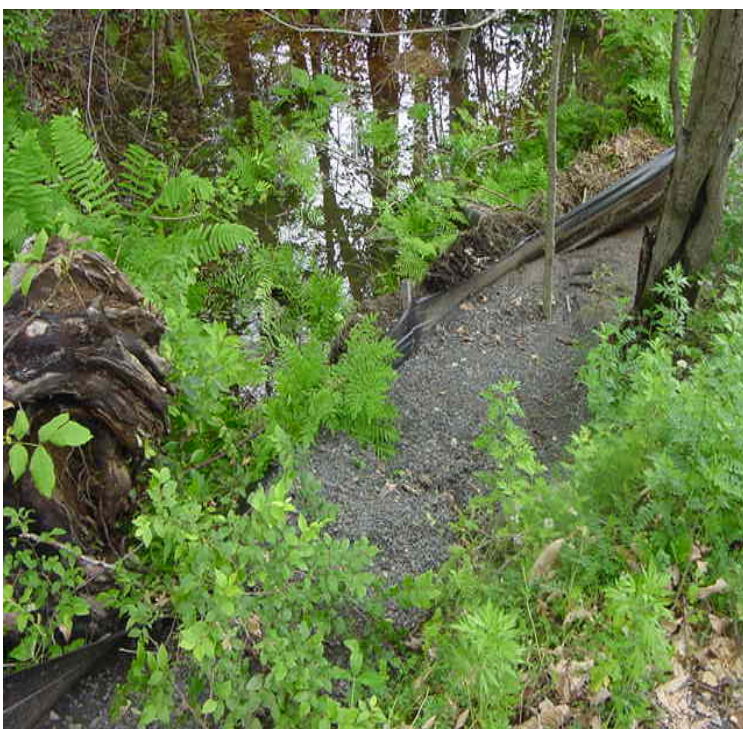
- A spot along the silt fence on the access drive in the ROW needs repair as stone washed over and built up here adjacent to the 2 nd wetland crossing. 5/17-6/28/06	- Repair fence and pull back stone as needed. Another spot is filling up but not overtopped. 5/17-6/28/06	- Needs attention (but may be overhead jurisdiction)

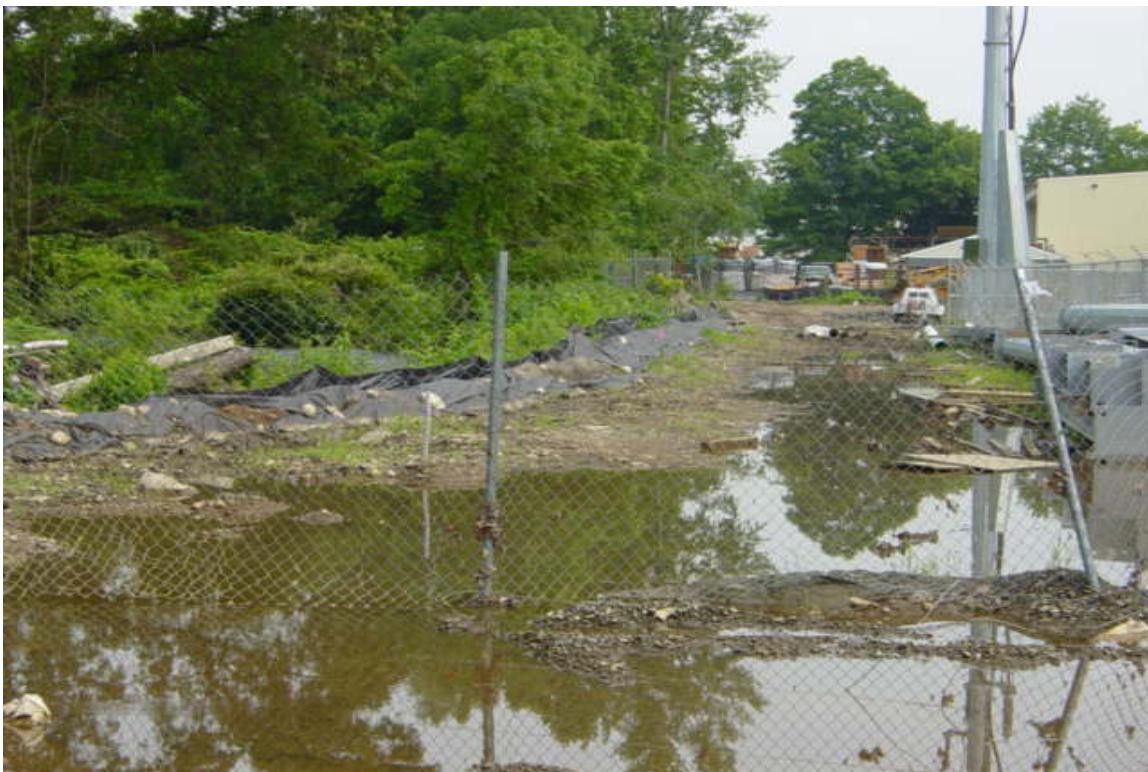
Norwalk Junction: Photo shows a view of the area along the station yard near the river with some areas of pooled water following the recent heavy rains. 6/29/06.

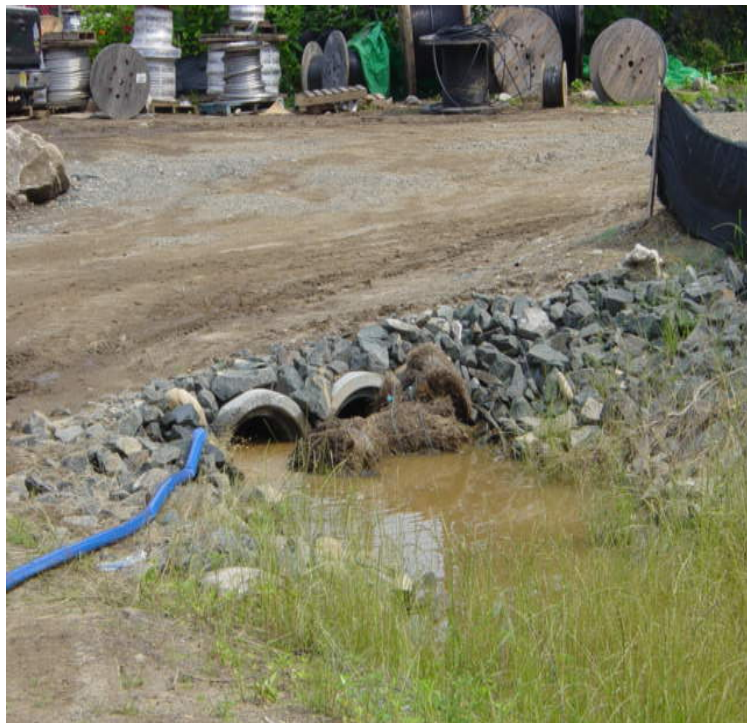
Areas of Inspection	Observation	Recommended Action	Corrected Actions
Norwalk Junction	-Active dewatering was noted in the swale. The haybales are degraded and turbid water was reaching the wetland area. 6/28/06.	-Replace haybales and reinforce controls. Some accumulated silt will be removed by 345kV crews. 6/28/06.	-N/A
Blasting	- All blasting is complete at this time. 6/28/06	- None at this time.	-N/A
Soils	- Some soil remains at the Archers Lane site from excavations but it is well contained. 6/28/06 - A number of soil stockpiles remain at Norwalk Junction as excavation continues. Large stockpiles have silt fence installed at the base. 5/4-6/28/06.	- None at this time 6/28/06. - Stockpiles remain contained. See erosion control section. 6/28/06. - Controls remain in place near 345kV stockpiles near the entrance to Norwalk	-N/A -N/A
Spills and Material Storage	- The concrete washout at the Hoyts Hill slope off the driveway was cleaned up. 6/28/06	- Continue to keep all vehicles maintained well (i.e. no apparent fluid leaks) if they will be used or stored on site - Report spills immediately, even if they are being controlled. - Take care not to get carried away and to be vigilant when refueling. Avoid refueling in the areas near the wetlands. See proper storage for all materials.	-The washout was cleaned up.

Photo on the left shows dewatering to the swale along the yard. Water is turbid and controls should be refreshed/improved. Photo on the right shows the wetland area at the end of the swale near the river filled with pooled turbid water again. 6/29/06.
